Southern California Edison's Design & Engineering Services (DES) group is responsible for this project. It was developed as part of Southern California Edison's Emerging Technology program under internal project number ET09SCE0070. DES' Charles Kim conducted this technology evaluation with overall guidance and management from Paul Delaney.

ICE QUALITY TESTING

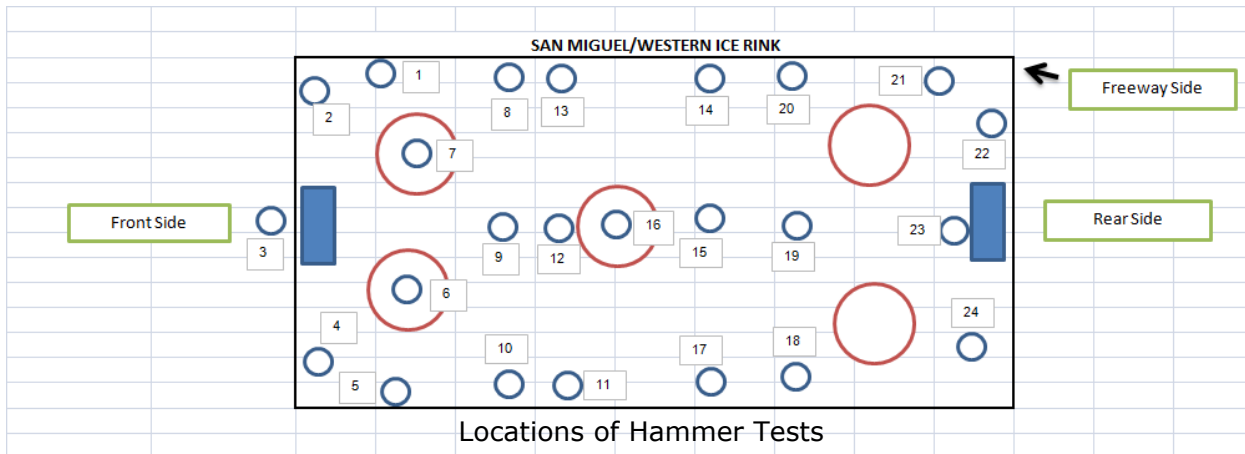
Pre Readings				Post Readings				% Change			
Number	Reading	Number	Reading	Number	Reading	Number	Reading	Number	Reading	Number	Reading
1	10	13	12	1	16	13	16	1	160%	13	133%
2	10	14	14	2	16	14	16	2	160%	14	114%
3	13.5	15	10	3	15	15	16	3	111%	15	160%
4	12.5	16	16	4	16	16	18	4	128%	16	113%
5	10.5	17	12.5	5	16	17	16	5	152%	17	128%
6	13	18	12	6	18	18	18	6	138%	18	150%
7	10	19	10	7	16	19	16	7	160%	19	160%
8	11.5	20	12	8	16	20	16	8	139%	20	133%
9	12.5	21	10	9	16	21	18	9	128%	21	180%
10	12.5	22	13.5	10	16	22	16	10	128%	22	119%
11	13	23	10	11	16	23	16	11	123%	23	160%
12	10	24	13	12	18	24	16	12	180%	24	123%
Pre Deviation				Post Deviation							
Max	16			Max	18						
Min	10			Min	15						
Avg	11.8333			Avg	16.375						
Deviation	51%			Deviation	18%

FIGURE 7. ICE QUALITY TESTING RESULTS FOR SAN MIGUEL ICE RINK OF THE TESTING SITE

The premise of the evaluation is that the ice would be of equal or better quality upon installation of the Realice system. The ice quality of pre condition is measured by testing surface strength of contact using a Schmidt Hammer. While this device is not designed to measure the lower surface strength of ice accurately, this device does allow a comparative test between pre and post conditions. Figure 7 and Figure 8 illustrate the ice quality testing results in terms of ice surface strengths.

- A reading on the Schmidt Hammer® corresponds to an approximate strength of 1500 psi. It does not provide a relationship curve below a reading of 20 and below. This is the main reason that the test should only be used on a comparative basis.
- The conclusion is that the rebound numbers are as good or better after the installation of the Realice system, which meets the intent of the M & V process.

For West Rink the ice was on average **39% harder** post installation of Realice with a high of 80% and low of 11 %.

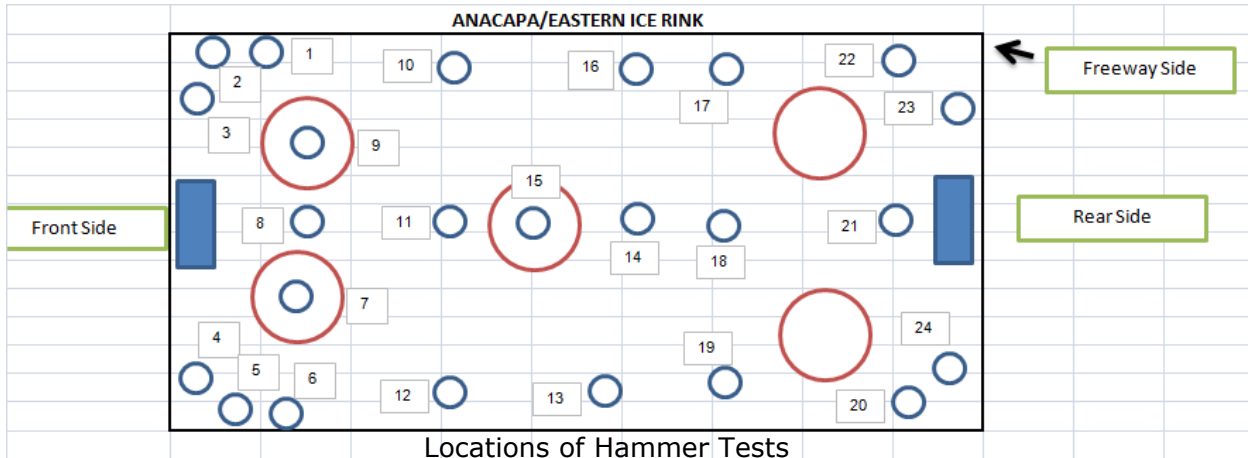
Locations of Hammer Tests

Pre Readings		Post Readings				% Change					
Number	Reading	Number	Reading	Number	Reading	Number	Reading	Number	Reading	Number	Reading
1	12	13	11.5	1	18	13	18	1	150%	13	157%
2	12.5	14	14	2	15	14	16	2	120%	14	114%
3	11	15	12.5	3	18	15	18	3	164%	15	144%
4	11	16	12	4	15	16	16	4	136%	16	133%
5	10	17	11	5	16	17	18	5	160%	17	164%
6	11.5	18	11.5	6	15	18	16	6	130%	18	139%
7	11	19	11.5	7	18	19	16	7	164%	19	139%
8	11	20	10	8	16	20	16	8	145%	20	160%
9	11	21	10	9	18	21	18	9	164%	21	180%
10	12.5	22	10	10	16	22	16	10	128%	22	160%
11	13	23	10.5	11	18	23	16	11	138%	23	152%
12	12	24	12	12	16	24	16	12	133%	24	133%
Pre Deviation		Post Deviation									
Max	14	Max	18								
Min	10	Min	15								
Avg	11.4583	Avg	16.625								
Deviation	35%	Deviation	18%

FIGURE 8. ICE QUALITY TESTING RESULTS FOR ANACAPA RINK OF THE TESTING SITE

For East Rink the ice was on average **46% harder** post installation of Realice with a high of 80% and a low of 14%.

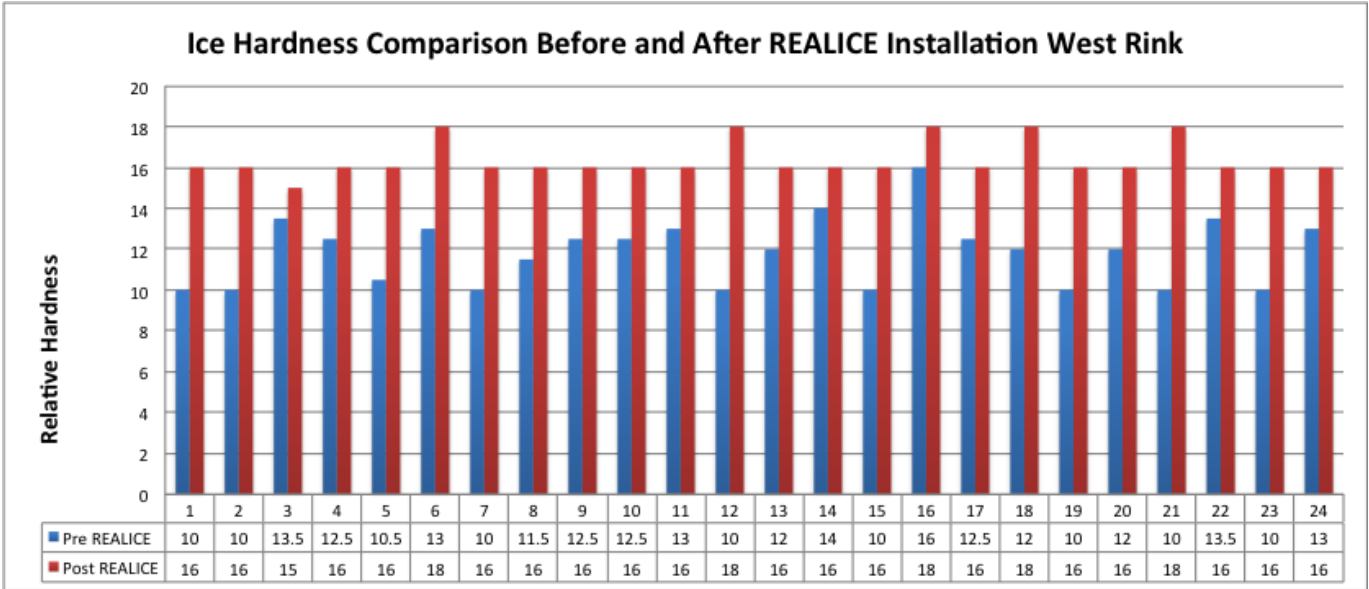
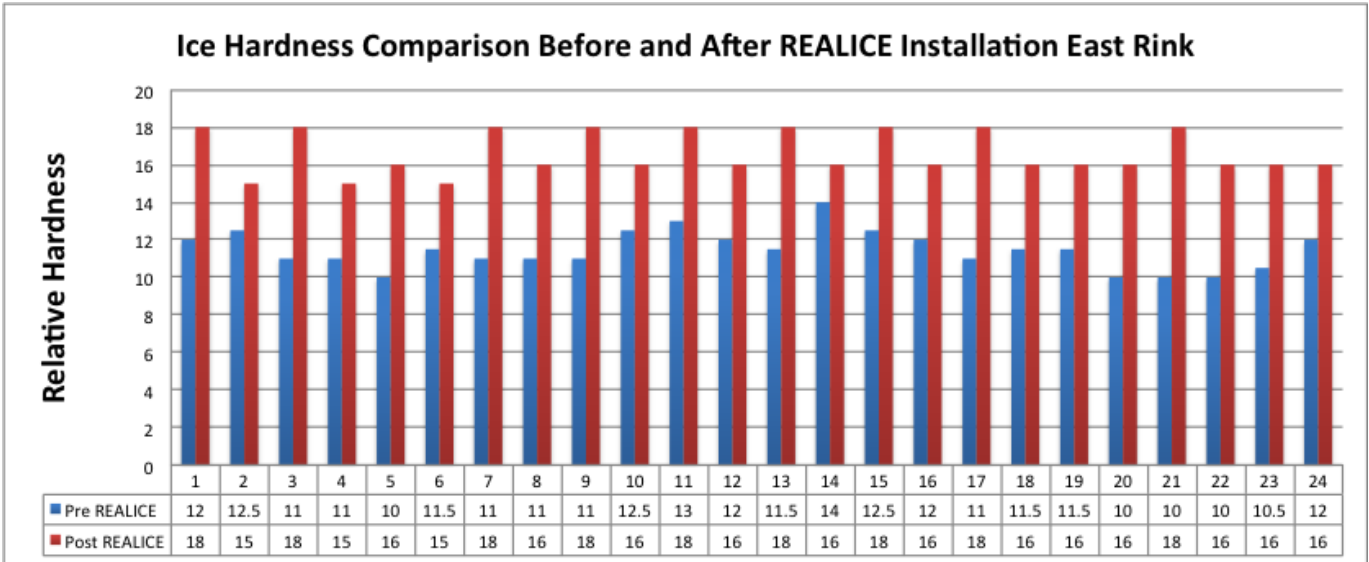
FIGURE 9. ICE QUALITY TESTING RESULTS FOR San Miguel-West and Anacapa- East Rinks

- The overall uniformity of ice strength is much better after the installation of the Realice system. This means that the ice was more consistent in hardness across the entire rink after installation.
